**Flood Control Project Maintenance
Levee Inspections**
LMA District Cover Sheet
Spring 2020 Levee Inspection Results

Lower San Joaquin Levee District

Spring 2020 Levee Inspection Results

Waterway			Bank	Unit Miles
Unit No. 01 San Joaquin River			Right	22.52
	Spring (March - May)	Summer (June - August)	(September - November) Fall	Winter (December - February)
Unit Maintenance Rating (Fall Only)				
Date of Inspection	4/21/2020 - 4/21/2020			
DWR Inspector	Corey Fujitani			
Accompanied By

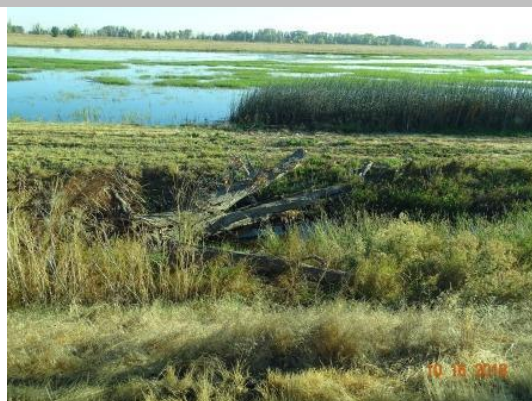
LM Start	13.15	Rating **	M	Issue No.	152
LM End	13.15	Issue Type +	Ma	Location *	LS
Category	Earthen Levee			GPS Latitude/Longitude	
				Start	End
Item	Encroachments			37.174444 °	37.174444 °
				-120.636589 °	-120.636589 °
DWR ID	DWR_NA0010_05_f _ 2018_152				
Comment Code					
TR : Tree or limb					
Inspector Comment					
There is a tree trunk on landside toe.

Tree trunk on landside toe. (Fall 2018)

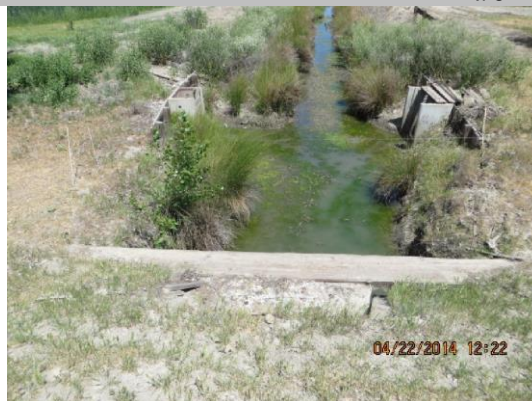
Comment Code					
Inspector Comment					
DS_ID:19708 FS_ID:34288 EP_NO: N/A Repair Type: Non-Urgent Crossing Status: Found UCIP Comments: 04/22/2014 Some erosion around headwall on the WS toe and there are animal burrows on both slopes. (DWR UCIP - W. Wylie) FIELD_STRUCT_DESC: 48-inch corrugated metal gravity drainage pipe through the levee, 10 feet below the crown. Flap gate on the waterside (WS) end. Flashboard attachment in concrete U-shaped headwall on the landside (LS) end. Concrete U-shaped headwall on the WS end. [Additional Reference(s): DWR Levee Log, 2002. USACE San Joaquin O&M Manual 601.1, 1967, (HLM 13.40)]. FS Date: 4/22/2014

Headwall and pipe on LS toe.

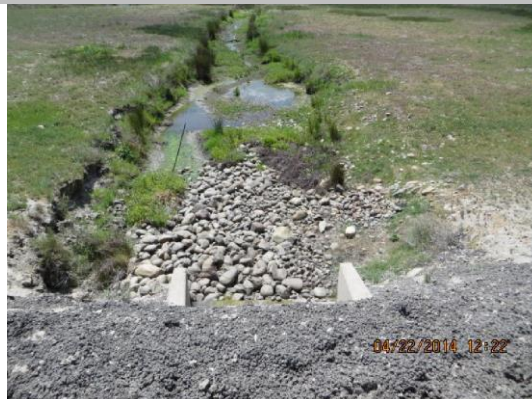
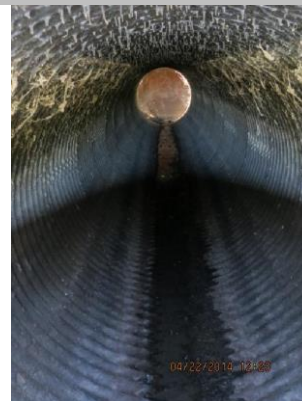
Headwall, flapgate, and pipe on WS toe.

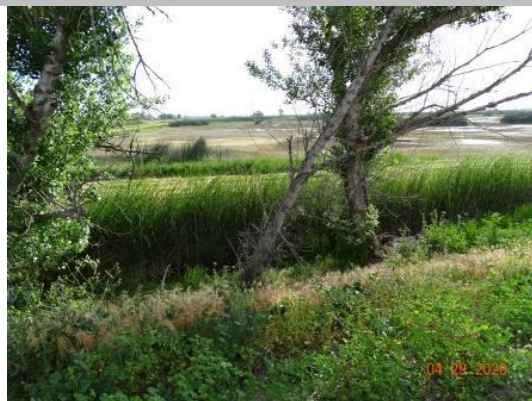
LM Start	13.44	Rating **	M	Issue No.	209
LM End	13.44	Issue Type +	Ma	Location *	LS
Category	Earthen Levee			GPS Latitude/Longitude	
				Start	End
Item	Encroachments			37.171249 °	37.171249 °
				-120.633157 °	-120.633157 °
DWR ID	DWR_NA0010_05_s _ 2020_209				
Comment Code					
TR : Tree or limb					
Inspector Comment					
Dead tree should be removed before it can damage the levee.

Dead tree falling over on the landside toe. (Spring 2020)

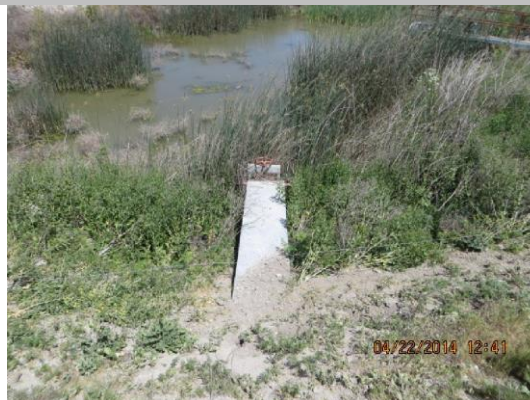
Walkway to gatevalve on LS shoulder.

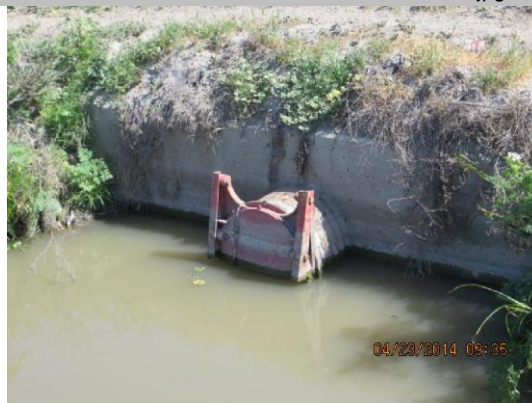
LM Start	13.85	Rating **	A/W	Issue No.	1341
LM End	13.85	Issue Type +	Ma	Location *	
Category	Supplemental			GPS Latitude/Longitude	
				Start	End
Item	DWR UCIP LMA Responsibility			37.166760 °	37.166760 °
				-120.628304 °	-120.628304 °
DWR ID	19710				
Comment Code					
Inspector Comment					
DS_ID:19710 FS_ID:34657 EP_NO: N/A Repair Type: No Action Needed Crossing Status: Found UCIP Comments: FIELD_STRUCT_DESC: 24-inch corrugated metal gravity drainage pipe through the levee, 12.4 feet below the crown. Flap gate on the waterside (WS) end. Concrete headwall on each end. [Additional Reference(s): DWR Levee Log, 2002. USACE San Joaquin O&M Manual 601.1, 1967, (HLM 13.83)]. FS Date: 4/23/2014 4:17:00 PM

Headwall, flapgate, and pipe on WS toe.

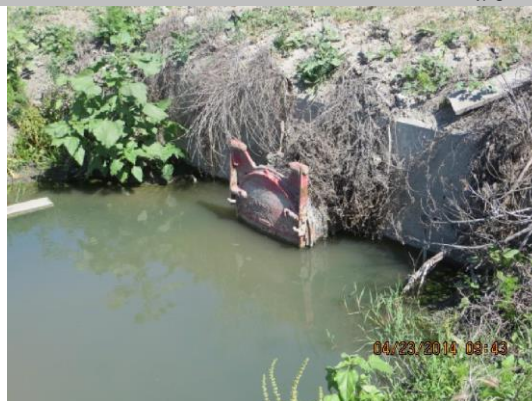
Headwall, pipe, and flapgate on WS toe.

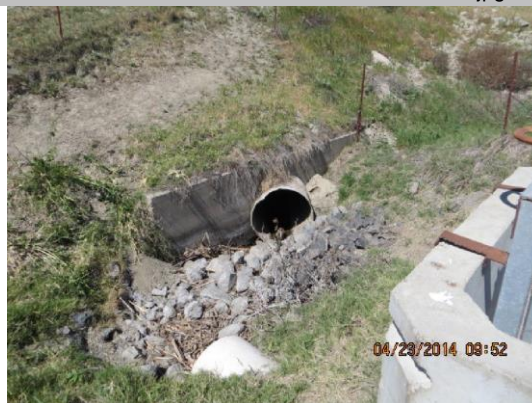
LM Start	15.11	Rating **	M	Issue No.	1343
LM End	15.11	Issue Type +	Ma	Location *	
Category	Supplemental			GPS Latitude/Longitude	
				Start	End
Item	DWR UCIP LMA Responsibility			37.156805 °	37.156805 °
				-120.609513 °	-120.609513 °
DWR ID	19712				
Comment Code					
Inspector Comment					
DS_ID:19712 FS_ID:34664 EP_NO: N/A Repair Type: Non-Urgent Crossing Status: Found UCIP Comments: 04/23/2014 Minor erosion at headwall on WS toe. (DWR UCIP - W. Wylie) FIELD_STRUCT_DESC: 36-inch corrugated metal gravity drainage pipe through the levee, 11.9 feet below the crown. Flap gate on the waterside (WS) end. Concrete headwall on each end. [Additional Reference(s): DWR Levee Log, 2002. USACE San Joaquin O&M Manual 601.1, 1967, (HLM 15.09)]. FS Date: 4/23/2014

Headwall and inlet on LS toe.

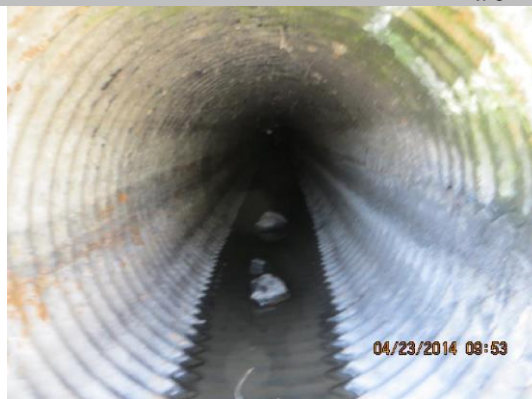
Inside pipe at LS toe.

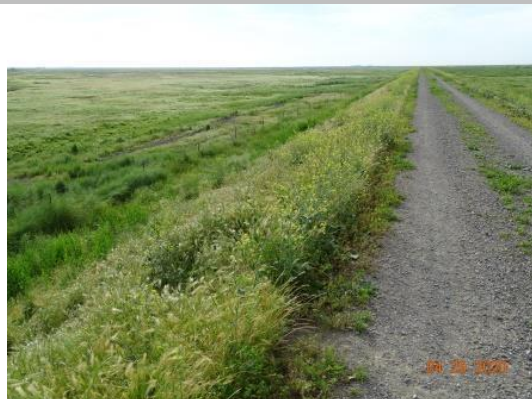
Photo 1 of 1 : SP_2020_NA0010_123_211_20200507_00357.jpg

LM Start	15.12	Rating **	U	Issue No.	211
LM End	16.00	Issue Type +	Ma	Location *	LS
Category	Earthen Levee			GPS Latitude/Longitude	
				Start	End
Item	Vegetation			37.156714 °	37.147266 °
				-120.609365 °	-120.598772 °
DWR ID	DWR_NA0010_05_s_2020_211				
Comment Code					
V1 : Control annual grass and weeds on the levee slopes and easements.					
Inspector Comment

Looking upstream along the landside slope. (Spring 2020)

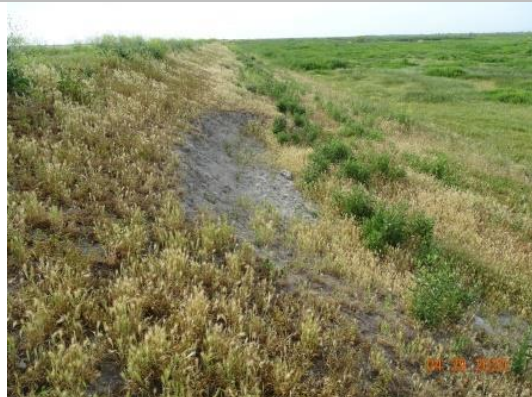
Photo 1 of 1 : SP_2020_NA0010_123_213_20200507_00358.jpg

LM Start	15.31	Rating **	M	Issue No.	213
LM End	15.31	Issue Type +	Ma	Location *	WS
Category	Earthen Levee			GPS Latitude/Longitude	
				Start	End
Item	Erosion / Bank Caving			37.154837 °	37.154837 °
				-120.606737 °	-120.606737 °
DWR ID	DWR_NA0010_05_s_ 2020_213				
Comment Code					
E1 : Note and monitor erosion site.					
Inspector Comment

View of erosion in the waterside slope. (Spring 2020)

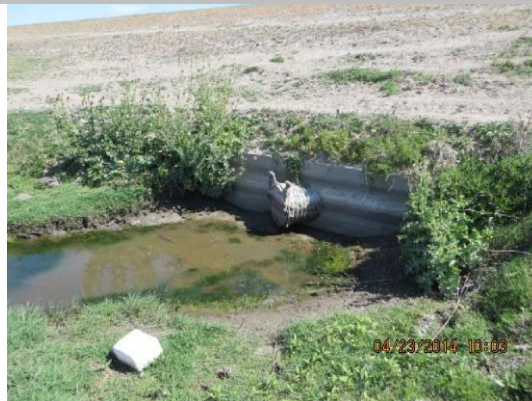
LM Start	15.76	Rating **	M	Issue No.	1344
LM End	15.76	Issue Type +	Ma	Location *	
Category	Supplemental			GPS Latitude/Longitude	
				Start	End
Item	DWR UCIP LMA Responsibility			37.150012 °	37.150012 °
				-120.601330 °	-120.601330 °
DWR ID	19713				
Comment Code					
Inspector Comment					
DS_ID:19713 FS_ID:39595 EP_NO: N/A Repair Type: Non-Urgent Crossing Status: Found UCIP Comments: 04/23/2014 Sediment buildup in pipe visible from landward side--recommend contacting owner to clear pipe. (DWR UCIP - W. Wylie) FIELD_STRUCT_DESC: 24-inch corrugated metal gravity drainage pipe through the levee, 11 feet below the crown. Flap gate on the waterside (WS) end. Concrete headwall on each end. [Additional Reference(s): DWR Levee Log, 2002. USACE San Joaquin O&M Manual 601.1, 1967, (HLM 15.74)]. FS Date: 4/23/2014

Headwall, pipe, and flapgate on WS toe.

Headwall and pipe at LS toe.

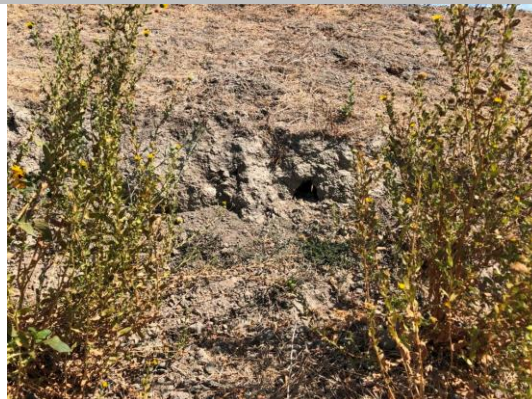
Photo 1 of 1 : SP_2020_NA0010_123_1_20200225_00002.jpg

LM Start	16.09	Rating **	M	Issue No.	1
LM End	16.13	Issue Type +	Ma	Location *	
Category	Supplemental			GPS Latitude/Longitude	
				Start	End
Item	DWR Erosion Survey			37.145965 °	37.145965 °
				-120.597597 °	-120.597597 °
DWR ID	NA0010U05RM13.85				
Comment Code					
Inspector Comment					
Site ID: NA0010U05RM13.85					
09/10/2019: The erosion has become worse during the past 2 flood seasons. The erosion length has increased to approximately 200 ft from 55 ft. Signs of animal activity were observed.					
09/20/2017: The erosion was discovered during spring levee inspection. The site is covered by dense vegetation and the measurements of the erosion are estimated.

Close-up view of the erosion.

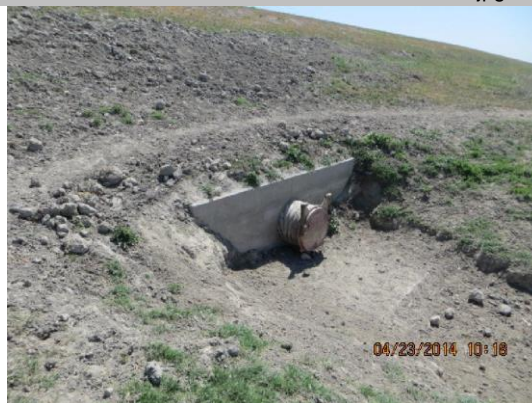
LM Start	16.68	Rating **	M	Issue No.	1346
LM End	16.68	Issue Type +	Ma	Location *	
Category	Supplemental			GPS Latitude/Longitude	
				Start	End
Item	DWR UCIP LMA Responsibility			37.138760 °	37.138760 °
				-120.592393 °	-120.592393 °
DWR ID	19716				
Comment Code					
Inspector Comment					
DS_ID:19716 FS_ID:34725 EP_NO: N/A Repair Type: Non-Urgent Crossing Status: Found UCIP Comments: 04/23/2014 Pipe heavily silted on LS toe. (DWR UCIP - W. Wylie) FIELD_STRUCT_DESC: 24-inch corrugated metal gravity drainage pipe through the levee, 10.5 feet below the crown. Flap gate on the waterside (WS) end. Concrete headwall on each end. [Additional Reference(s): DWR Levee Log, 2002. USACE San Joaquin O&M Manual 601.1, 1967, (HLM 16.67)]. FS Date: 4/23/2014

Headwall, flapgate, and pipe visible on WS toe.

Concrete headwall and pipe visible on LS toe.

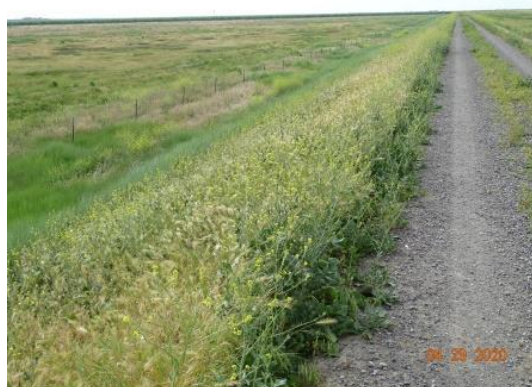
Photo 1 of 1 : SP_2020_NA0010_123_216_20200507_00359.jpg

LM Start	16.77	Rating **	U	Issue No.	216
LM End	17.43	Issue Type +	Ma	Location *	LS
Category	Earthen Levee			GPS Latitude/Longitude	
				Start	End
Item	Vegetation			37.137766 °	37.129337 °
				-120.591536 °	-120.585879 °
DWR ID	DWR_NA0010_05_s_2020_216				
Comment Code					
V1 : Control annual grass and weeds on the levee slopes and easements.					
Inspector Comment

View of vegetation growing on the landside slope. (Spring 2020)

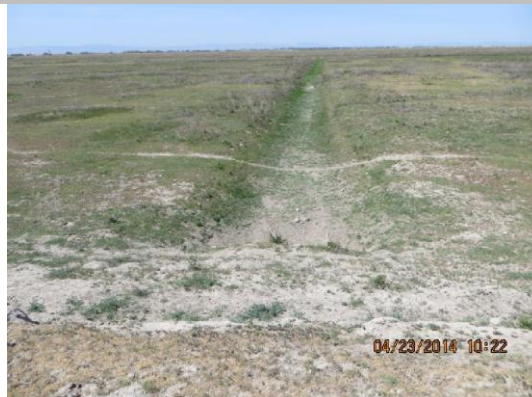
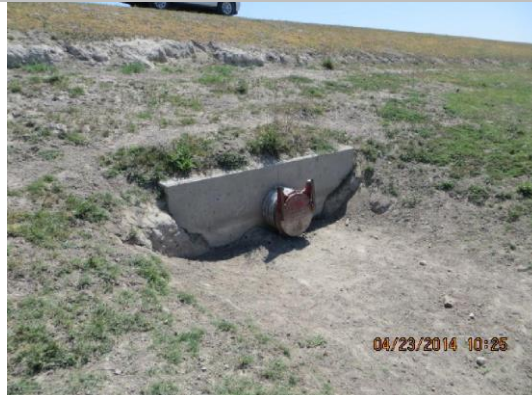
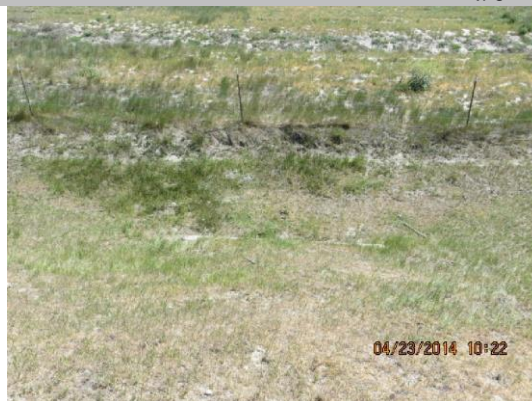
LM Start	17.22	Rating **	M	Issue No.	1347
LM End	17.22	Issue Type +	Ma	Location *	
Category	Supplemental			GPS Latitude/Longitude	
				Start	End
Item	DWR UCIP LMA Responsibility			37.132211 °	37.132211 °
				-120.587106 °	-120.587106 °
DWR ID	19717				
Comment Code					
Inspector Comment					
DS_ID:19717 FS_ID:39597 EP_NO: N/A Repair Type: Non-Urgent Crossing Status: Found UCIP Comments: 04/23/2014 Sediment buildup in pipe visible from landward side--recommend contacting owner to clear pipe. (DWR UCIP - W. Wylie) FIELD_STRUCT_DESC: 24-inch corrugated metal gravity drainage pipe through the levee, 12 feet below the crown. Flap gate on the waterside (WS) end. Concrete headwall on each end. [Additional Reference(s): DWR Levee Log, 2002. USACE San Joaquin O&M Manual 601.1, 1967, (HLM 17.20)]. FS Date: 4/23/2014

Headwall, flapgate, and pipe visible on WS toe.

Headwall and pipe visible on LS toe.

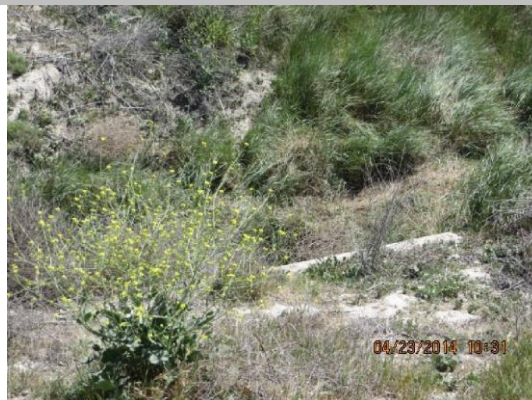
LM Start	17.54	Rating **	M	Issue No.	1348
LM End	17.54	Issue Type +	Ma	Location *	
Category	Supplemental			GPS Latitude/Longitude	
				Start	End
Item	DWR UCIP LMA Responsibility			37.127843 °	37.127843 °
				-120.585245 °	-120.585245 °
DWR ID	19743				
Comment Code					
Inspector Comment					
DS_ID:19743 FS_ID:39599 EP_NO: N/A Repair Type: Non-Urgent Crossing Status: Found UCIP Comments: 04/23/2014 Sediment buildup in pipe visible from landward side--recommend contacting owner to clear pipe. (DWR UCIP - W. Wylie) FIELD_STRUCT_DESC: 24-inch corrugated metal gravity drainage pipe through the levee, 9.8 feet below the crown. Flap gate on the waterside (WS) end. Concrete headwall on each end. [Additional Reference(s): DWR Levee Log, 2002. USACE San Joaquin O&M Manual 601.1, 1967, (HLM 17.52)]. FS Date: 4/23/2014

Headwall, pipe, and flapgate visible on WS toe.

Pipe and headwall visible on LS toe.

Inside pipe on LS toe.

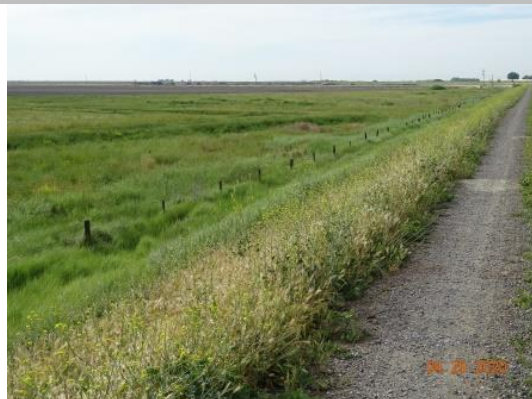
Photo 1 of 1 : SP_2020_NA0010_123_218_20200507_00360.jpg

LM Start	17.72	Rating **	U	Issue No.	218
LM End	19.56	Issue Type +	Ma	Location *	LS
Category	Earthen Levee			GPS Latitude/Longitude	
				Start	End
Item	Vegetation			37.125360 °	37.112598 °
				-120.584189 °	-120.559427 °
DWR ID	DWR_NA0010_05_s_2020_218				
Comment Code					
V1 : Control annual grass and weeds on the levee slopes and easements.					
Inspector Comment

View of the landside slope looking upstream. (Spring 2020)

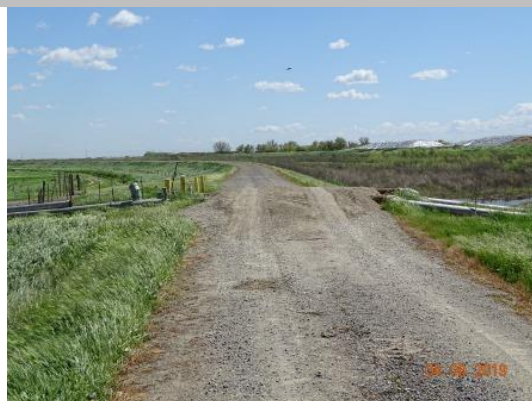
Photo 1 of 1 : SP_2020_NA0010_123_112_20200225_00022.jpg

LM Start	18.06	Rating **	U	Issue No.	112
LM End	18.06	Issue Type +	En	Location *	CR
Category	Earthen Levee			GPS Latitude/Longitude	
				Start	End
Item	Encroachments			37.120690 °	37.120690 °
				-120.582218 °	-120.582218 °
DWR ID	DWR_NA0010_05_s_2017_112				
Comment Code					
PI : Pipe					
Inspector Comment					
There are 3 temporary eight inch pipes across the levee crown going down both slopes.

View of pipe encroachment looking upstream along the levee crown. (Spring 2019)

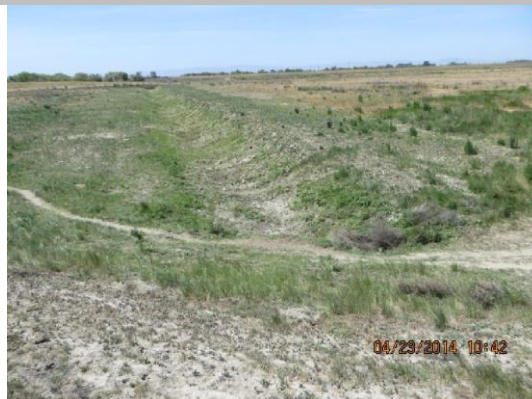
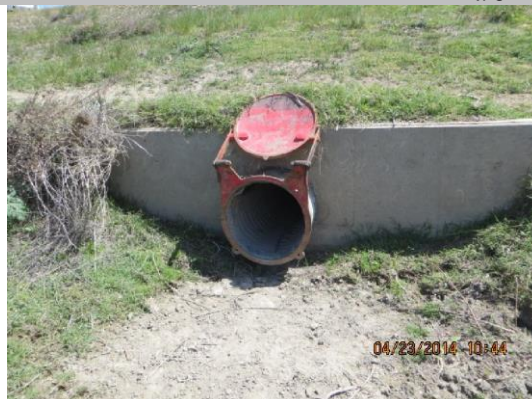
LM Start	18.09	Rating **	M	Issue No.	1349	
LM End	18.09	Issue Type +	Ma	Location *		
Category	Supplemental			GPS Latitude/Longitude		
				Start		End
Item	DWR UCIP LMA Responsibility			37.120309 °		37.120309 °
				-120.582041 °		-120.582041 °
DWR ID	19745					
Comment Code						
Inspector Comment						
DS_ID:19745 FS_ID:34747 EP_NO: N/A Repair Type: Non-Urgent Crossing Status: Found UCIP Comments: 04/23/2014 Animal burrows in levee on both slopes. (DWR UCIP - W. Wylie) FIELD_STRUCT_DESC: 24-inch corrugated metal gravity drainage pipe through the levee, 12.4 feet below the crown. Flap gate on the waterside (WS) end. Concrete headwall on each end. [Additional Reference(s): DWR Levee Log, 2002. USACE San Joaquin O&M Manual 601.1, 1967, (HLM 18.07)]. FS Date: 4/23/2014

Headwall, pipe, and flapgate on WS toe.

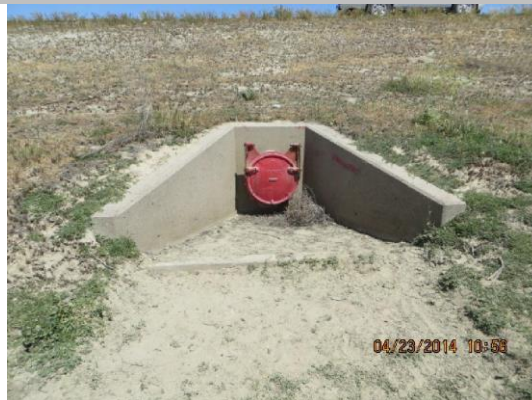
Comment Code						
Inspector Comment						
DS_ID:19747						
FS_ID:39601						
EP_NO: N/A						
Repair Type: Non-Urgent						
Crossing Status: Found						
UCIP Comments: 04/23/2014 Sediment buildup in pipe visible from landward side--recommend contacting owner to clear pipe. (DWR UCIP - W. Wylie)						
FIELD_STRUCT_DESC: 24-inch corrugated metal gravity drainage pipe through the levee, 10 feet below the crown. Flap gate on the waterside (WS) end. Concrete headwall on the landside (LS) end. Concrete U-shaped headwall on the WS end. [Additional Reference(s): DWR Levee Log, 2002. USACE San Joaquin O&M Manual 601.1, 1967, (HLM 19.11)].						
FS Date: 4/23/2014

Headwall, pipe, and flapgate visible on WS toe.

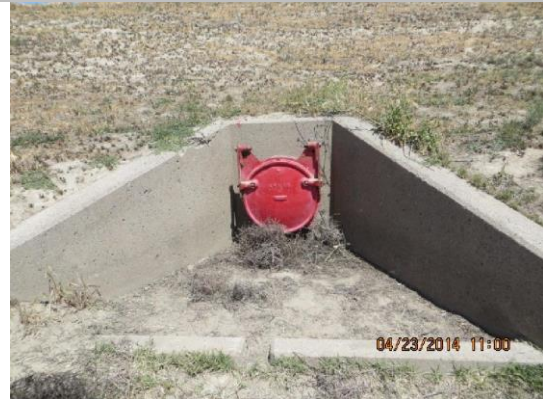
Photo 2 of 3 : UCIP_SP_2020_34751_62511.jpg

LM Start	19.17	Rating **	A/W	Issue No.	1352 (cont)
LM End	19.17	Issue Type +	Ma	Location *	
Category	Supplemental		GPS Latitude/Longitude		
			Start	End	
Item	DWR UCIP LMA Responsibility		37.115463 °	37.115463 °	
			-120.565086 °	-120.565086 °	
DWR ID	19776

Headwall, pipe, and flapgate visible on WS toe.

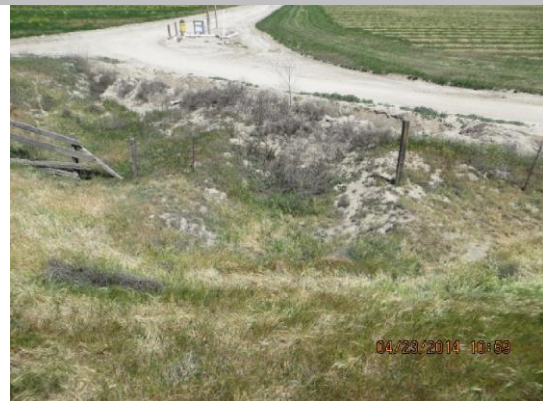
Photo 3 of 3 : UCIP_SP_2020_34751_62510.jpg

LM Start	19.17	Rating **	A/W	Issue No.	1352 (cont)
LM End	19.17	Issue Type +	Ma	Location *

Headwall and pipe visible on LS toe.

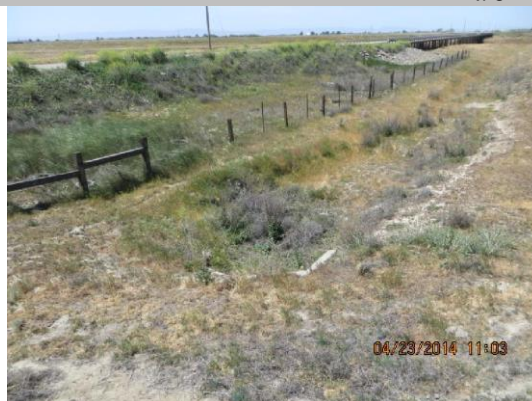
Photo 1 of 3 : UCIP_SP_2020_39602_62514.jpg

LM Start	19.48	Rating **	M	Issue No.	1353	
LM End	19.48	Issue Type +	Ma	Location *		
Category	Supplemental			GPS Latitude/Longitude		
				Start		End
Item	DWR UCIP LMA Responsibility			37.113542 °	37.113542 °	
				-120.560389 °	-120.560389 °	
DWR ID	19777					
Comment Code						
Inspector Comment						
DS_ID:19777 FS_ID:39602 EP_NO: N/A Repair Type: Non-Urgent Crossing Status: Found UCIP Comments: 04/23/2014 Sediment buildup in pipe visible from landward side--recommend contacting owner to clear pipe. (DWR UCIP - W. Wylie) FIELD_STRUCT_DESC: 24-inch corrugated metal gravity drainage pipe through the levee, 9 feet below the crown. Flap gate on the waterside (WS) end. Concrete headwall on the landside (LS) end. Concrete U-shaped headwall on the WS end. [Additional Reference(s): DWR Levee Log, 2002. USACE San Joaquin O&M Manual 601.1, 1967, (HLM 19.46)]. FS Date: 4/23/2014

Headwall, pipe, and flapgate visible on WS toe.

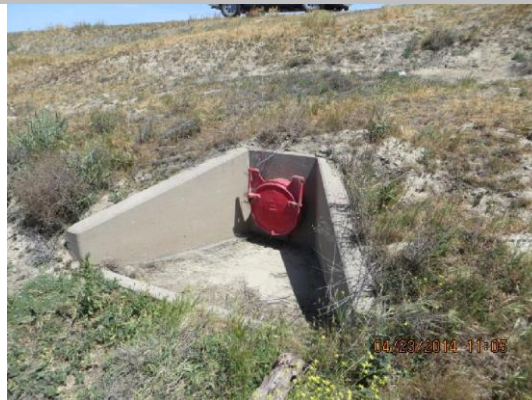
Photo 2 of 3 : UCIP_SP_2020_39602_62516.jpg

Headwall, pipe, and flapgate visible on WS toe.

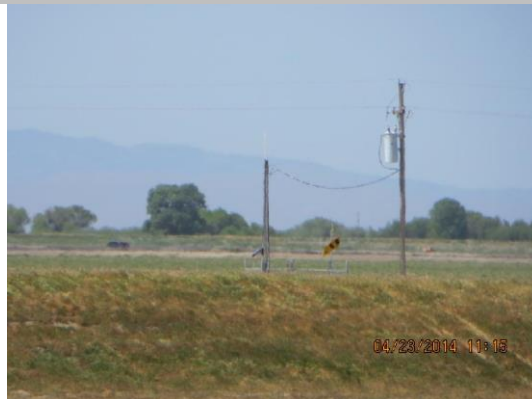
Photo 2 of 2 : UCIP_SP_2020_39345_71476.jpg

Gasline marker off LS of opposite bank.

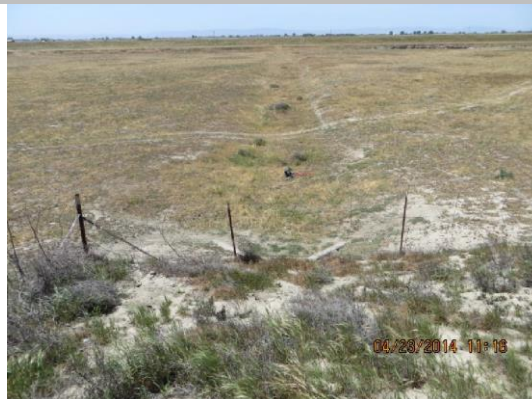
Photo 1 of 3 : UCIP_SP_2020_39603_62519.jpg

DS_ID:19778
 FS_ID:39603
 EP_NO: N/A
 Repair Type: Non-Urgent
 Crossing Status: Found
 UCIP Comments: 04/23/2014 Dense vegetation limits the inspector's visibility to identify signs of pipe failure (leaks) along the landward slope. Recommend removing vegetation along pipe alignment to conduct proper inspection of structure. Sediment buildup in pipe visible from landward side--recommend contacting owner to clear pipe. (DWR UCIP - W. Wylie)
 FIELD_STRUCT_DESC: 24-inch corrugated metal gravity drainage pipe through the levee, 9.7 feet below the crown. Flap gate on the waterside (WS) end. Concrete headwall on the landside (LS) end. Concrete U-shaped headwall on the WS end. [Additional Reference(s): DWR Levee Log, 2002. USACE San Joaquin O&M Manual 601.1, 1967, (HLM 19.50)].
 FS Date: 4/23/2014

Headwall, pipe, and flapgate visible on WS toe.

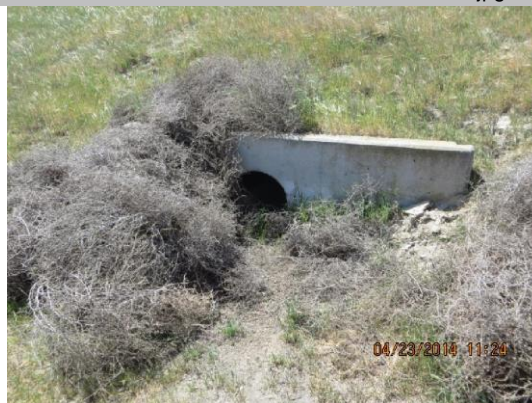
Photo 2 of 3 : UCIP_SP_2020_34754_62524.jpg

Headwall and pipe visible on LS toe.

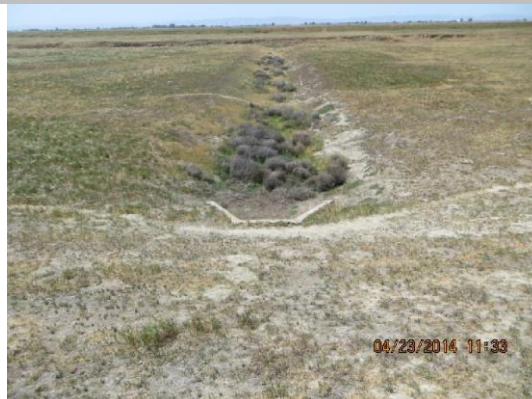
Photo 1 of 3 : UCIP_SP_2020_34757_62533.jpg

LM Start	20.10	Rating **	A/W	Issue No.	1358
LM End	20.10	Issue Type +	Ma	Location *	
Category	Supplemental			GPS Latitude/Longitude	
				Start	End
Item	DWR UCIP LMA Responsibility			37.107091 °	37.107091 °
				-120.553503 °	-120.553503 °
DWR ID	19781				
Comment Code					
Inspector Comment					
DS_ID:19781 FS_ID:34757 EP_NO: N/A Repair Type: No Action Needed Crossing Status: Found UCIP Comments: FIELD_STRUCT_DESC: 36-inch corrugated metal gravity drainage pipe through the levee, 9.9 feet below the crown. Flap gate on the waterside (WS) end. Concrete headwall on the landside (LS) end. Concrete U-shaped headwall on the WS end. [Additional Reference(s): DWR Levee Log, 2002. USACE San Joaquin O&M Manual 601.1, 1967, (HLM 20.05)]. FS Date: 4/23/2014

Headwall, pipe, and flapgate visible on WS toe.

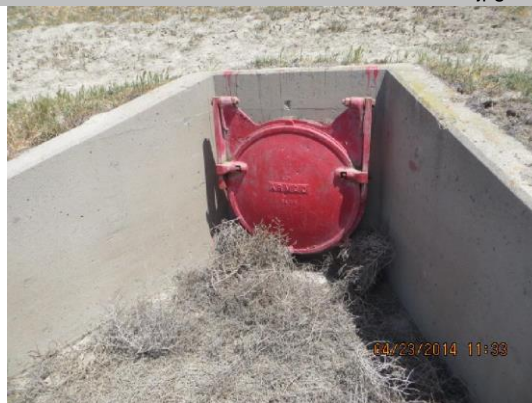
Photo 2 of 3 : UCIP_SP_2020_34757_62532.jpg

Headwall, pipe, and flapgate visible on WS toe.

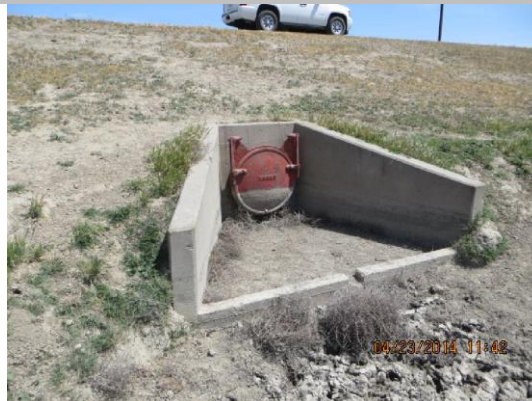
Photo 2 of 3 : UCIP_SP_2020_34760_62541.jpg

Headwall, pipe, and flapgate visible on WS toe.

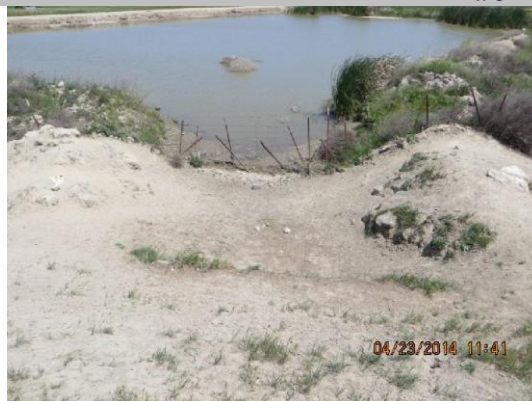
Photo 3 of 3 : UCIP_SP_2020_34760_62540.jpg

Headwall and pipe visible on LS toe.

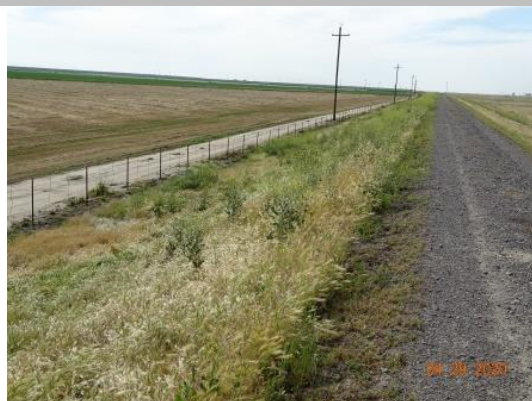
Photo 1 of 1 : SP_2020_NA0010_123_220_20200507_00361.jpg

LM Start	20.42	Rating **	U	Issue No.	220
LM End	23.24	Issue Type +	Ma	Location *	LS
Category	Earthen Levee			GPS Latitude/Longitude	
				Start	End
Item	Vegetation			37.103477 °	37.073146 °
				-120.549844 °	-120.516816 °
DWR ID	DWR_NA0010_05_s_2020_220				
Comment Code					
V1 : Control annual grass and weeds on the levee slopes and easements.					
Inspector Comment

Looking upstream along the landside slope. (Spring 2020)

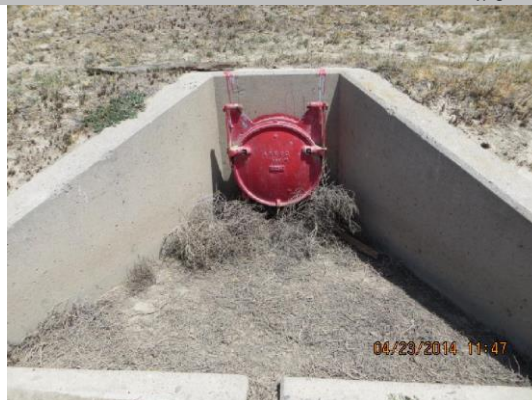
Photo 2 of 3 : UCIP_SP_2020_39605_62543.jpg

Headwall, pipe, and flapgate visible on WS toe.

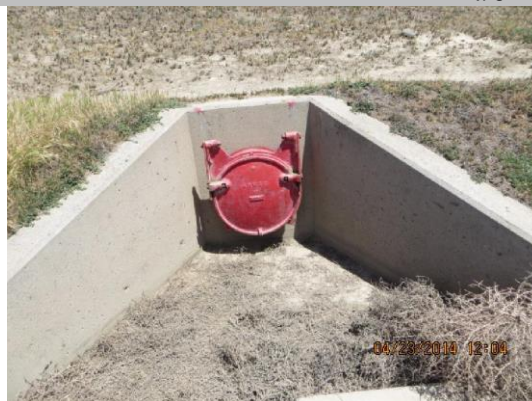
Photo 2 of 3 : UCIP_SP_2020_39606_62551.jpg

Headwall, pipe, and flapgate visible on WS toe.

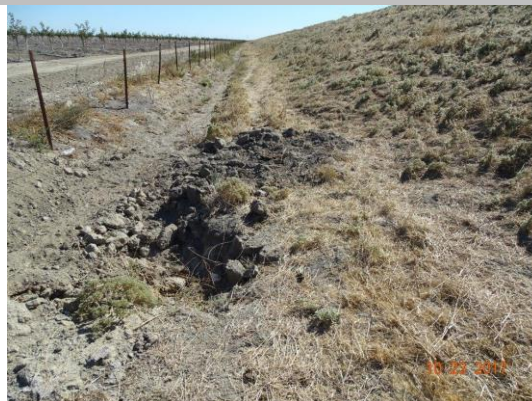
Photo 1 of 1 : SP_2020_NA0010_123_120_20200225_00027.jpg

LM Start	21.45	Rating **	M	Issue No.	120
LM End	21.45	Issue Type +	Ma	Location *	LS
Category	Earthen Levee			GPS Latitude/Longitude	
				Start	End
Item	Erosion / Bank Caving			37.092064 °	37.092064 °
				-120.537750 °	-120.537750 °
DWR ID	DWR_NA0010_05_f _ 2017_120				
Comment Code					
E2 : Schedule repair of erosion site prior to the next inspection.					
Inspector Comment					
Repair holes dug at the landside toe.

Looking southeast at the landside toe.

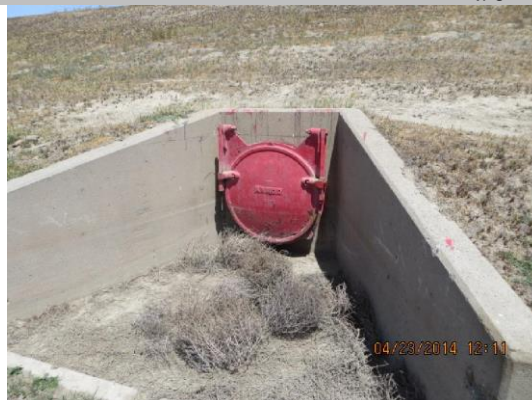
Photo 2 of 3 : UCIP_SP_2020_39614_62556.jpg

Headwall, pipe, and flapgate visible on WS toe.

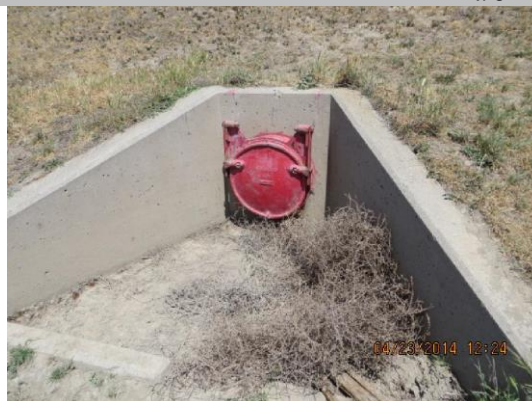
Photo 2 of 3 : UCIP_SP_2020_39883_62558.jpg

Headwall, pipe, and flapgate visible on WS toe.

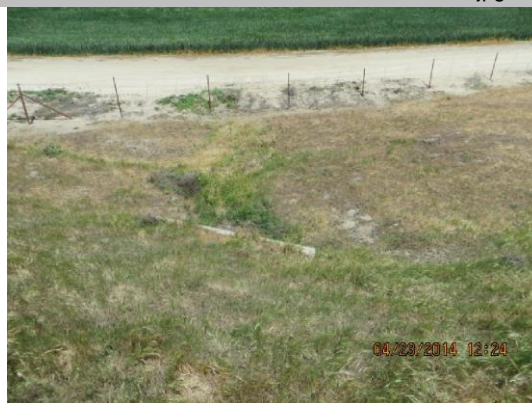
Photo 3 of 3 : UCIP_SP_2020_39883_62560.jpg

Headwall and pipe visible on LS toe.

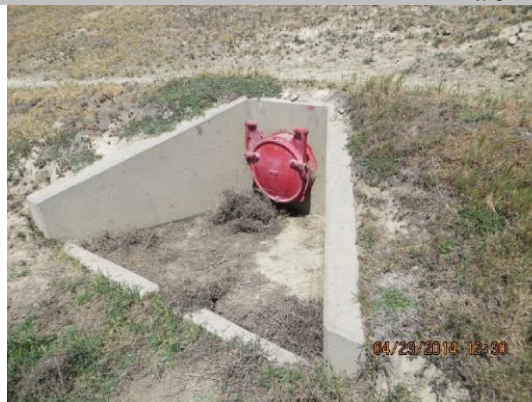
Comment Code					
Inspector Comment					
DS_ID:19788 FS_ID:39610 EP_NO: N/A Repair Type: Non-Urgent Crossing Status: Found UCIP Comments: 04/23/2014 Dense vegetation limits the inspector's visibility to identify signs of pipe failure (leaks) along the landward slope. Recommend removing vegetation along pipe alignment to conduct proper inspection of structure. (DWR UCIP - W. Wylie) FIELD_STRUCT_DESC: 24-inch corrugated metal gravity drainage pipe through the levee, 10.7 feet below the crown. Flap gate on the waterside (WS) end. Concrete headwall on the landside (LS) end. Concrete U-shaped headwall on the WS end. [Additional Reference(s): DWR Levee Log, 2002. USACE San Joaquin O&M Manual 601.1, 1967, (HLM 21.85)]. FS Date: 4/23/2014

Headwall, pipe, and flapgate visible on WS toe.

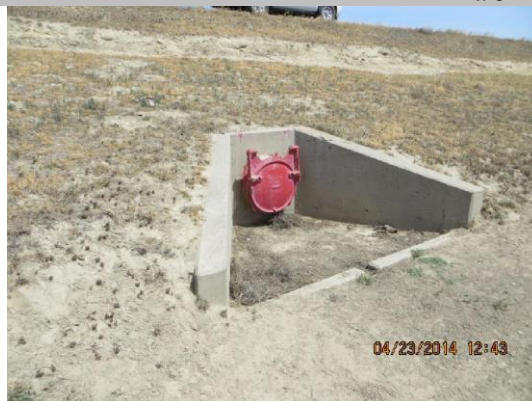
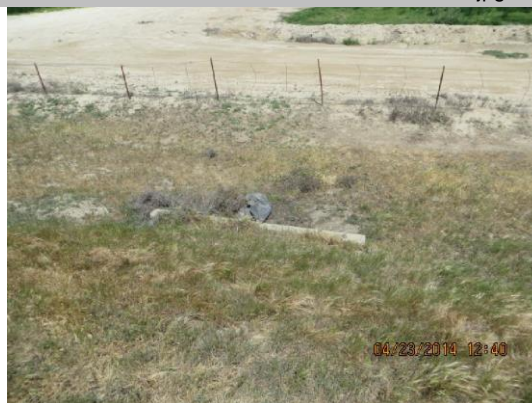
LM Start	22.28	Rating **	M	Issue No.	1366 (cont)
LM End	22.28	Issue Type +	Ma	Location *	
Category	Supplemental		GPS Latitude/Longitude		
			Start	End	
Item	DWR UCIP LMA Responsibility		37.083410 °	37.083410 °	
			-120.528356 °	-120.528356 °	
DWR ID	19789

Headwall, pipe, and flapgate visible on WS toe.

Headwall and pipe visible on LS toe.

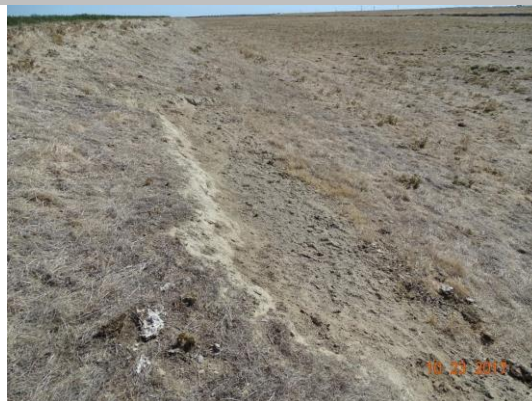
Photo 1 of 1 : SP_2020_NA0010_123_121_20200225_00028.jpg

LM Start	22.35	Rating **	M	Issue No.	121
LM End	22.35	Issue Type +	Ma	Location *	WS
Category	Earthen Levee			GPS Latitude/Longitude	
				Start	End
Item	Animal Control			37.082696 °	37.082696 °
				-120.527620 °	-120.527620 °
DWR ID	DWR_NA0010_05_f_2017_121				
Comment Code					
A2 : Repair the levee slope damaged by livestock and prevent large animal access.					
Inspector Comment					
Waterside slope damaged by animal traffic.

Looking southeast at the waterside slope.

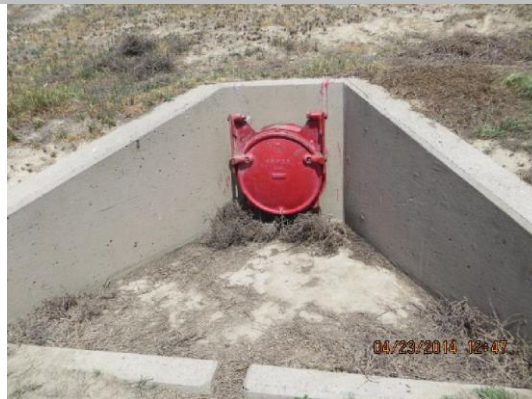
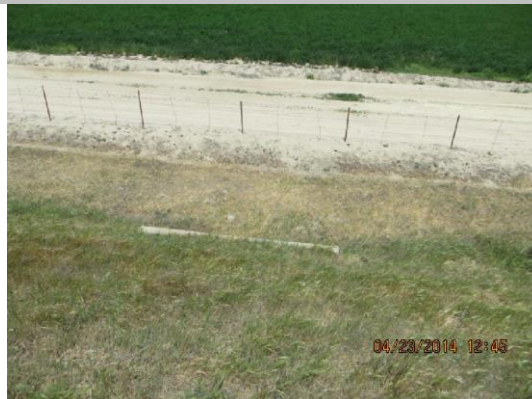
DS_ID:19790
FS_ID:39613
EP_NO: N/A
Repair Type: Non-Urgent
Crossing Status: Found
UCIP Comments: 04/23/2014 Dense vegetation limits the inspector's visibility to identify signs of pipe failure (leaks) along the landward slope. Recommend removing vegetation along pipe alignment to conduct proper inspection of structure. Sediment buildup in pipe visible from landward side--recommend contacting owner to clear pipe. (DWR UCIP - W. Wylie)
FIELD_STRUCT_DESC: 24-inch corrugated metal gravity drainage pipe through the levee, 10.4 feet below the crown. Flap gate on the waterside (WS) end. Concrete headwall on the landside (LS) end. Concrete U-shaped headwall on the WS end. [Additional Reference(s): DWR Levee Log, 2002. USACE San Joaquin O&M Manual 601.1, 1967, (HLM 22.46)].
FS Date: 4/23/2014

Headwall, pipe, and flapgate visible on WS toe.

Headwall and pipe visible on LS toe.

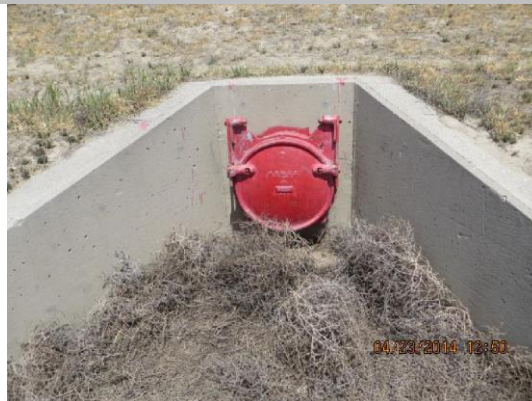
DS_ID:19791
FS_ID:39616
EP_NO: N/A
Repair Type: Non-Urgent
Crossing Status: Found
UCIP Comments: 04/23/2014 Dense vegetation limits the inspector's visibility to identify signs of pipe failure (leaks) along the landward slope. Recommend removing vegetation along pipe alignment to conduct proper inspection of structure. Sediment buildup in pipe visible from landward side--recommend contacting owner to clear pipe. (DWR UCIP - W. Wylie)
FIELD_STRUCT_DESC: 24-inch corrugated metal gravity drainage pipe through the levee, 12.2 feet below the crown. Flap gate on the waterside (WS) end. Concrete headwall on the landside (LS) end. Concrete U-shaped headwall on the WS end. [Additional Reference(s): DWR Levee Log, 2002. USACE San Joaquin O&M Manual 601.1, 1967, (HLM 22.79)].
FS Date: 4/23/2014

Headwall, pipe, and flapgate visible on WS toe.

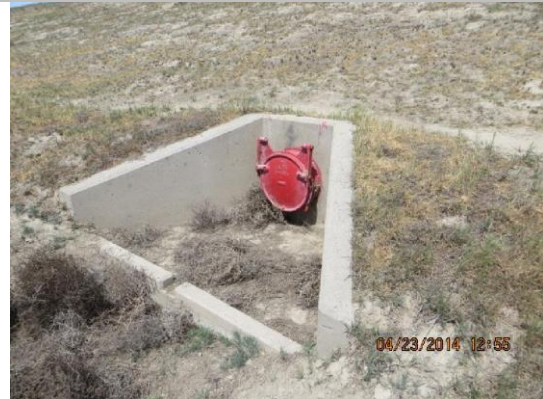
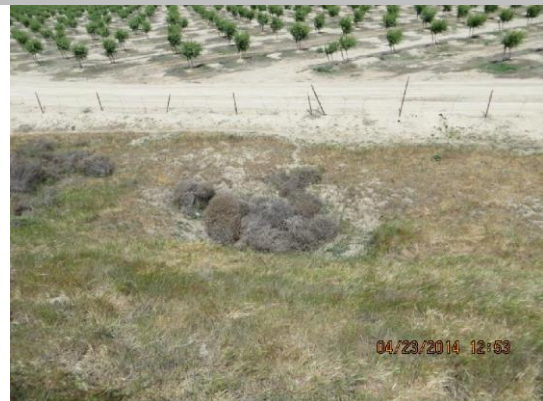
LM Start	23.03	Rating **	M	Issue No.	1369 (cont)
LM End	23.03	Issue Type +	Ma	Location *	
Category	Supplemental		GPS Latitude/Longitude		
			Start	End	
Item	DWR UCIP LMA Responsibility		37.075387 °	37.075387 °	
			-120.519406 °	-120.519406 °	
DWR ID	19792

Headwall, pipe, and flapgate visible on WS toe.

Headwall and pipe visible on LS toe.

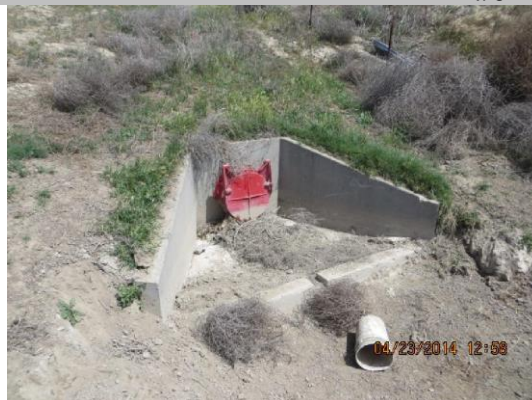
Comment Code						
Inspector Comment						
DS_ID:19793 FS_ID:39618 EP_NO: N/A Repair Type: Non-Urgent Crossing Status: Found UCIP Comments: 04/23/2014 Debris blocking closure of outlet. Dense vegetation limits the inspector's visibility to identify signs of pipe failure (leaks) along the waterward and landward slopes. Recommend removing vegetation along pipe alignment to conduct proper inspection of structure. (DWR UCIP - W. Wylie) FIELD_STRUCT_DESC: 24-inch corrugated metal gravity drainage pipe through the levee, 11.5 feet below the crown. Flap gate on the waterside (WS) end. Concrete headwall on the landside (LS) end. Concrete U-shaped headwall on the WS end. [Additional Reference(s): DWR Levee Log, 2002]. FS Date: 4/23/2014

Headwall, pipe, and flapgate visible on WS toe.

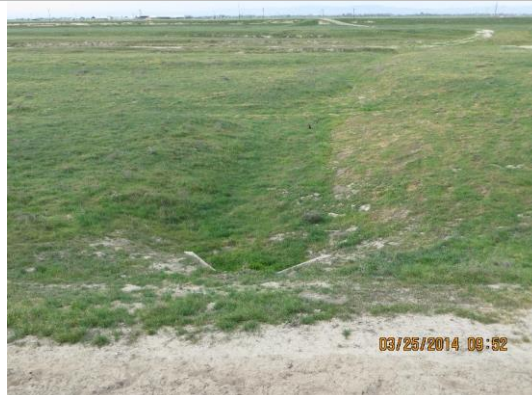
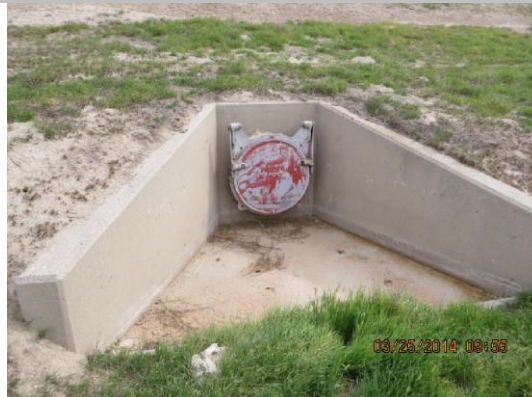
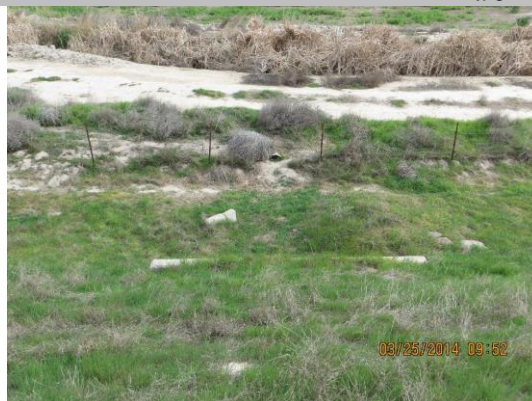
LM Start	23.25	Rating **	A/W	Issue No.	1371
LM End	23.25	Issue Type +	Ma	Location *	
Category	Supplemental			GPS Latitude/Longitude	
				Start	End
Item	DWR UCIP LMA Responsibility			37.072989 °	37.072989 °
				-120.516687 °	-120.516687 °
DWR ID	19794				
Comment Code					
Inspector Comment					
DS_ID:19794 FS_ID:32763 EP_NO: N/A Repair Type: No Action Needed Crossing Status: Found UCIP Comments: FIELD_STRUCT_DESC: 30-inch corrugated metal gravity drainage pipe through the levee, 11.6 feet below the crown. Flap gate on the waterside (WS) end. Concrete headwall on the landside (LS) end. Concrete U-shaped headwall on the WS end. [Additional Reference(s): DWR Levee Log, 2002. USACE San Joaquin O&M Manual 601.1, 1967, (HLM 23.15)]. FS Date: 3/25/2014 9:04:45 AM

Concrete headwall on WS toe.

Flapgate and concrete headwall on WS toe.

Concrete headwall on LS toe.

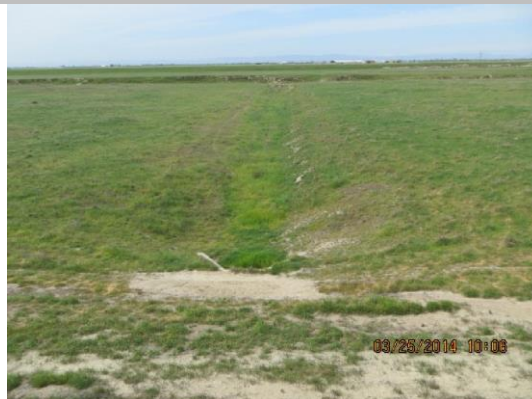
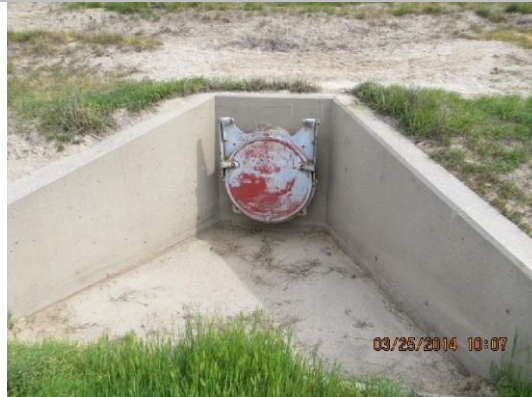
LM Start	23.72	Rating **	M	Issue No.	1372	
LM End	23.72	Issue Type +	Ma	Location *		
Category	Supplemental			GPS Latitude/Longitude		
				Start		End
Item	DWR UCIP LMA Responsibility			37.067799 °		37.067799 °
				-120.511093 °		-120.511093 °
DWR ID	19796					
Comment Code						
Inspector Comment						
DS_ID:19796 FS_ID:39621 EP_NO: N/A Repair Type: Non-Urgent Crossing Status: Found UCIP Comments: 03/25/2014 Sediment buildup in pipe visible from landward side--recommend contacting owner to clear pipe. (DWR UCIP - W. Wylie) FIELD_STRUCT_DESC: 30-inch corrugated metal gravity drainage pipe through the levee, 12.1 feet below the crown. Flap gate on the waterside (WS) end. Concrete U-shaped headwall on the WS end. [Additional Reference(s): DWR Levee Log, 2002. USACE San Joaquin O&M Manual 601.1, 1967, (HLM 23.62)]. FS Date: 3/25/2014

Concrete headwall on WS toe.

Flapgate on Concrete headwall on WS toe.

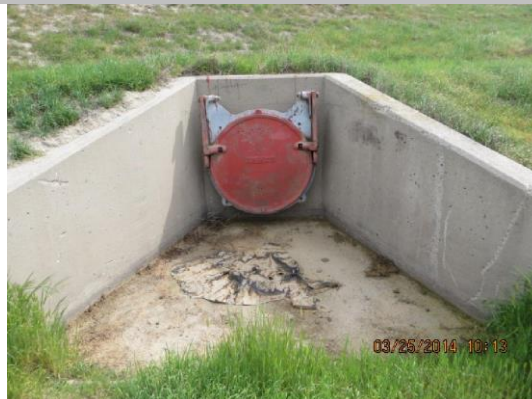
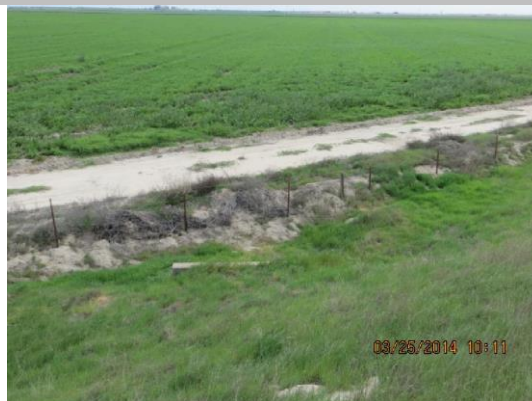
DS_ID:19797
FS_ID:39620
EP_NO: N/A
Repair Type: Non-Urgent
Crossing Status: Found
UCIP Comments: 03/25/2014 Minor sediment/debris buildup in pipe visible from landward side--recommend contacting owner to clear pipe. (DWR UCIP - W. Wylie)
FIELD_STRUCT_DESC: 36-inch corrugated metal gravity drainage pipe through the levee, 12.1 feet below the crown. Flap gate on the waterside (WS) end. Concrete headwall on the landside (LS) end. Concrete U-shaped headwall on the WS end. [Additional Reference(s): DWR Levee Log, 2002. USACE San Joaquin O&M Manual 601.1, 1967, (HLM 23.85)].
FS Date: 3/25/2014

Flapgate at Concrete headwall on WS toe.

Concrete headwall on LS toe.

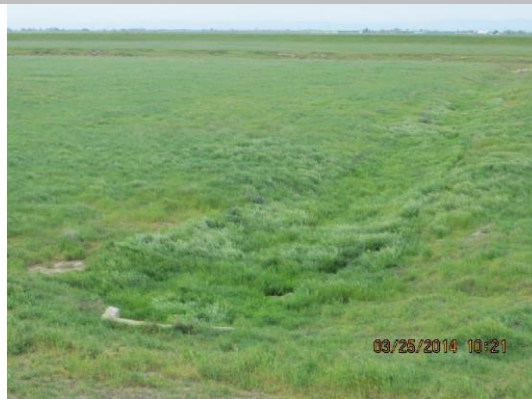
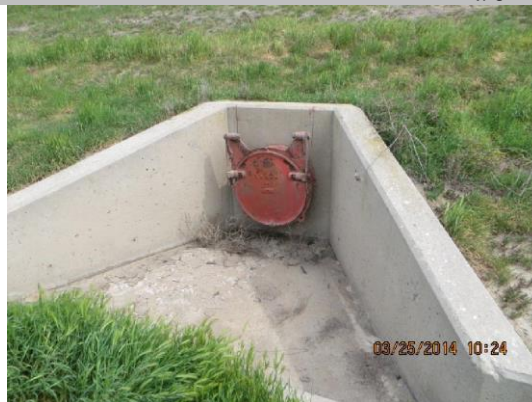
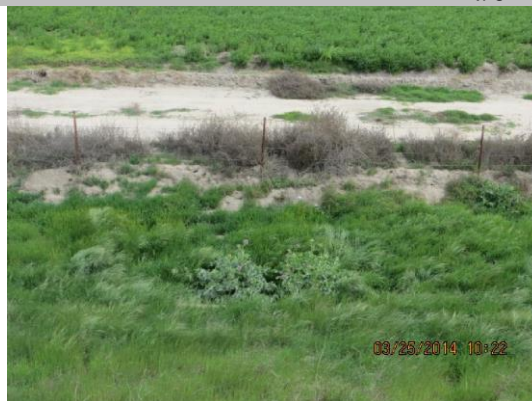
Comment Code					
Inspector Comment					
DS_ID:19798 FS_ID:46850 EP_NO: N/A Repair Type: Non-Urgent Crossing Status: Found UCIP Comments: 03/25/2014 Dense vegetation limits the inspector's visibility to identify signs of pipe failure (leaks) along the landward slope. Recommend removing vegetation along pipe alignment to conduct proper inspection of structure. (DWR UCIP - W. Wylie) FIELD_STRUCT_DESC: 24-inch corrugated metal gravity drainage pipe through the levee, 11.2 feet below the crown. Flap gate on the waterside (WS) end. Concrete headwall on the landside (LS) end. Concrete U-shaped headwall on the WS end. [Additional Reference(s): DWR Levee Log, 2002. USACE San Joaquin O&M Manual 601.1, 1967, (HLM 24.18)]. FS Date: 3/25/2014

Concrete headwall at WS toe.

Flapgate at concrete headwall at WS toe.

Concrete headwall at LS toe.

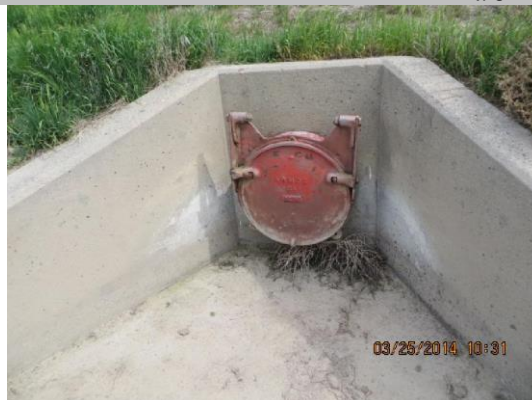
Comment Code					
Inspector Comment					
DS_ID:19799 FS_ID:39623 EP_NO: N/A Repair Type: Non-Urgent Crossing Status: Found UCIP Comments: 03/25/2014 Dense vegetation limits the inspector's visibility to identify signs of pipe failure (leaks) along the landward slope. Recommend removing vegetation along pipe alignment to conduct proper inspection of structure. (DWR UCIP - W. Wylie) FIELD_STRUCT_DESC: 24-inch corrugated metal gravity drainage pipe through the levee, 11.2 feet below the crown. Flap gate on the waterside (WS) end. Concrete headwall on the landside (LS) end. Concrete U-shaped headwall on the WS end. [Additional Reference(s): DWR Levee Log, 2002. USACE San Joaquin O&M Manual 601.1, 1967, (HLM 24.46)]. FS Date: 3/25/2014

Concrete headwall on WS toe.

Flapgate at Concrete headwall on WS toe.

Concrete headwall on LS toe.

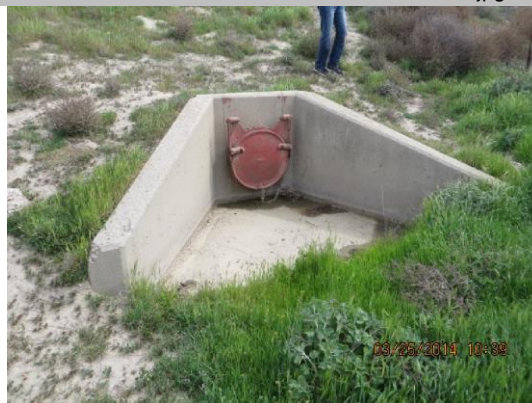
Photo 2 of 3 : UCIP_SP_2020_32786_59295.jpg

Flapgate on concrete headwall on WS toe.

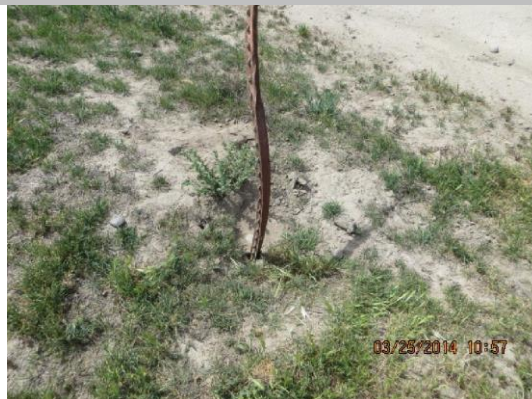
Photo 2 of 3 : UCIP_SP_2020_41716_59307.jpg

Buried Siphon breaker on WS shoulder.

Comment Code						
Inspector Comment						
DS_ID:19802 FS_ID:41716 EP_NO: 12873 Repair Type: Non-Urgent Crossing Status: Found UCIP Comments: 03/25/2014 Clear soil from siphon breaker and install a protective riser. (DWR UCIP - W. Wylie) FIELD_STRUCT_DESC: 16-inch coated steel irrigation discharge pipe through the levee, 2 feet below the crown. Slant pump at the channel on the waterside (WS) toe. Siphon breaker on the WS shoulder. Gate valve on the landside (LS) toe. A preexisting ditch runs from the WS toe to the channel. Riprap placed around the intake. 2-inch polyvinyl chloride (PVC) electrical conduit at the same location. (Plans to install a pump with a discharge pipe through the levee authorized under Permit No. 12873, 1980 - Bowles Farming Company). [Additional Reference(s): DWR Levee Log, 2002]. FS Date: 3/25/2014

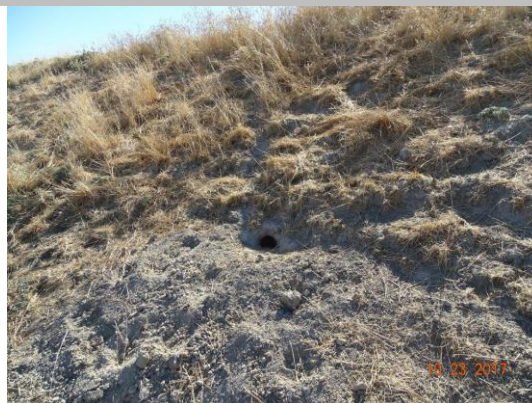
Photo 1 of 1 : SP_2020_NA0010_123_123_20200225_00029.jpg

Looking southwest at the landside slope.

LM Start	25.09	Rating **	M	Issue No.	123
LM End	25.26	Issue Type +	Ma	Location *	LS
Category	Earthen Levee			GPS Latitude/Longitude	
				Start	End
Item	Animal Control			37.053103 °	37.051252 °
				-120.494651 °	-120.492368 °
DWR ID	DWR_NA0010_05_f_2017_123				
Comment Code					
A1 : Exterminate rodents and backfill and compact or grout burrows.					
Inspector Comment

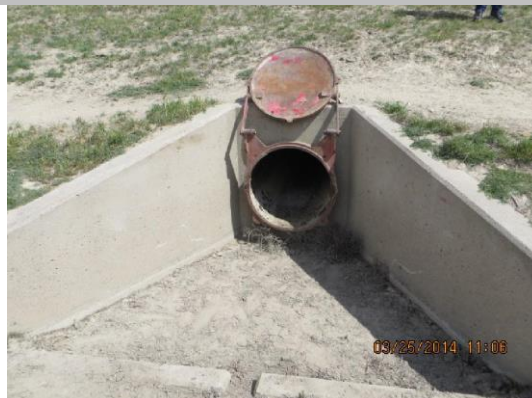
Photo 2 of 3 : UCIP_SP_2020_32789_59312.jpg

Concrete headwall and flapgate on WS toe.

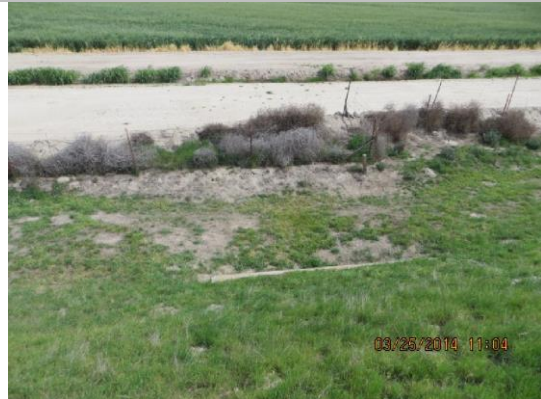
Photo 3 of 3 : UCIP_SP_2020_32789_59310.jpg

Concrete headwall on LS toe.
